# **INDOOR AIR QUALITY ASSESSMENT**

**Forbush Memorial Library  
118 Main Street  
Westminster, Massachusetts**

Prepared by:  
Massachusetts Department of Public Health  
Bureau of Environmental Health  
Indoor Air Quality Program  
December 2007

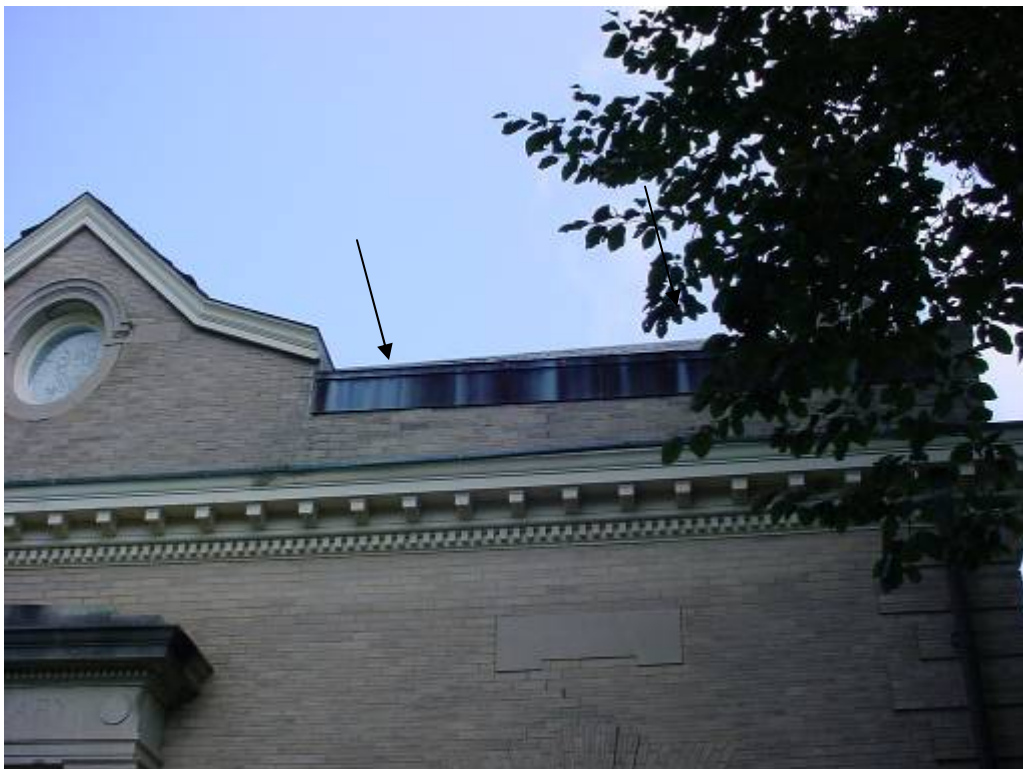
**Picture 28**

The roof of the original building has slate shingles, which are significantly heavier than asphalts or other modern roofing materials. In addition, the roof of the original building was designed to support the weight of the slate roof and the snow load typical for the area; such support is contingent on a full compliment of original rafters. The removal of the original rafters would serve to undermine the ability of the roof to carry the weight, or deadload, of the roof structure as well as load created by accumulating snow on the roof. The renovations, which included installation of AHU, associated ductwork and the attic floor, created additional weight to an already load-compromised roof. This compounding weight load coupled with the removal of supporting rafters has likely caused instability, resulting in a variety of damage (i.e. bowing, cracking) noted in the original building.

BEH staff agree with the decision to restrict access to the Eloranta Room, due to the obvious sinking of the roof in the original building. In this condition, high winds or significant snow cover may result in further damage to the roof and exterior walls.

**Depressed Roof Line of Original Building**

1. Continue with efforts to repair the roof and exterior walls of the original building.  
Further damage to the building envelope will likely lead to leaks through the roof or exterior walls.
